TP 14090E

***Louis S. St. Laurent Propeller
Damage Analyses***

Prepared for
Transportation Development Centre
Transport Canada

April 2003

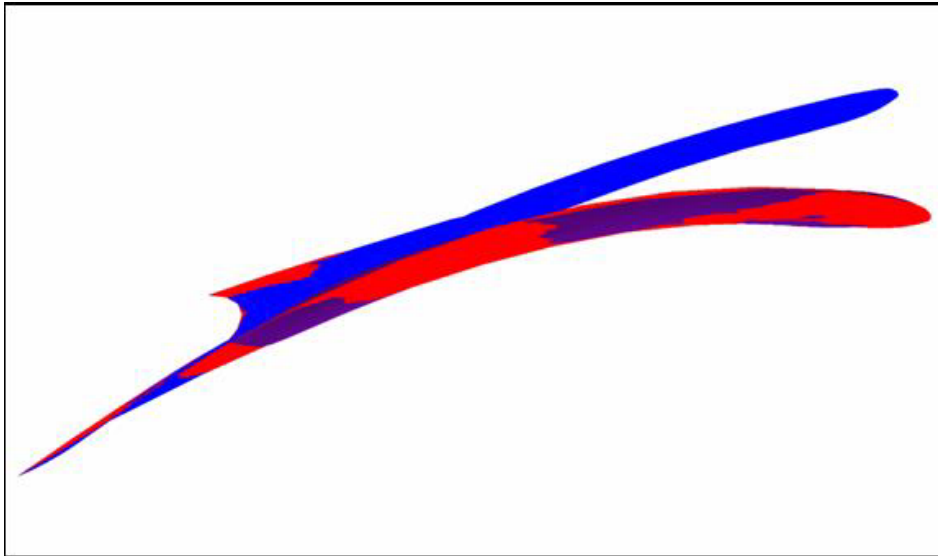
Figure 1: Original Starboard Blade + Blade 1 Casting + FEA Rebounded Model

The damaged shapes of four of the propeller blades were captured by taking rigid polymer castings on the dockside. The castings were then measured in BMT FTL's laboratories and the measurements were used to recreate the deformed propellers. Loads were then applied to the FE models to generate matching deformations. The procedure used was iterative, and had to take account of the fact that the castings represent the residual deformations of the blades rather than the peak deformations under the applied loads. In all cases, it was possible to achieve a reasonably good match between the castings and the FE models, as shown in Figure 1. The casting and FEA models coincide over the bulk of the blade surface.

The loads required to produce the deformations are summarized in Table 2. The total loads are considered to be reasonably accurate, while the areas and pressures may be less so. However, the pressure/area data is quite consistent with other ice load data. For all four blades that were successfully analyzed, the stresses under the applied load exceeded the material yield strength over much of the blade, and approached ultimate for the most highly loaded blades.

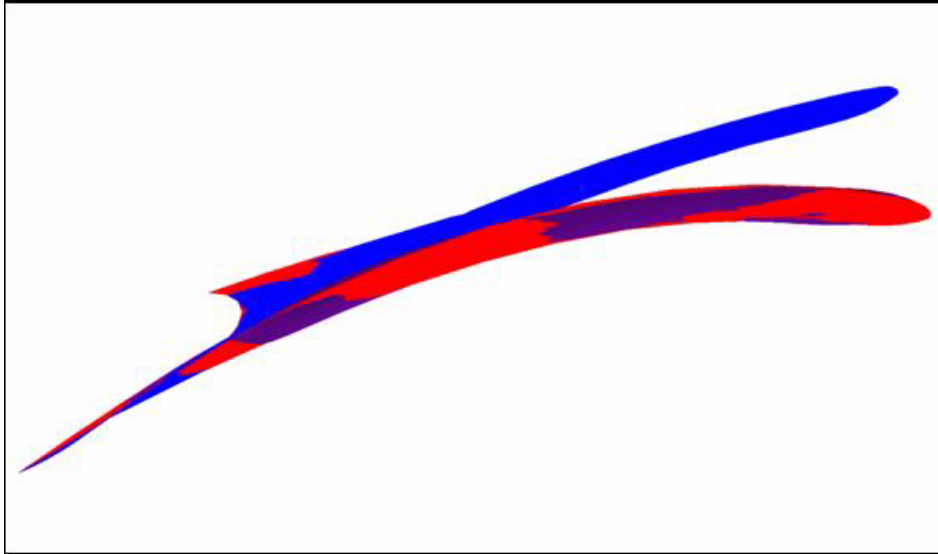
Figure 1: Pale d'hélice tribord originale + Moulage de pale 1 + Modèle AEF du retour élastique

Pour saisir les profils endommagés de quatre pales d'hélice, des moulages en polymère rigide ont été pris à quai. Les moulages ont été ensuite mesurés dans les laboratoires de BMT FTL et les résultats ont servi à recréer les hélices déformées. Des charges ont été appliquées aux modèles à éléments finis pour générer des déformations correspondantes. Les chercheurs ont alors utilisé pour cela une méthode itérative, et ils devaient tenir compte du fait que les moulages représentaient les déformations résiduelles des pales plutôt que les pics de déformations sous les charges appliquées. Il a été possible dans tous les cas de réaliser une correspondance relativement bonne entre les moulages et les modèles à éléments finis, comme l'illustre la figure 1. Le moulage et les modèles d'analyse par éléments finis (AEF) coïncident avec la majeure partie de la surface de la pale.

Le tableau 2 contient les charges requises pour produire les déformations. On estime que les valeurs des charges totales sont raisonnablement précises, alors que les valeurs de surfaces et de pressions peuvent l'être moins. Or, les données de pression de surface correspondent passablement aux autres données sur les charges de glace. Pour les quatre pales analysées avec succès, les contraintes sous la charge appliquée sont supérieures à la limite élastique de la majeure partie de la pale, et se rapprochent de la résistance maximale dans le cas des pales les plus chargées.

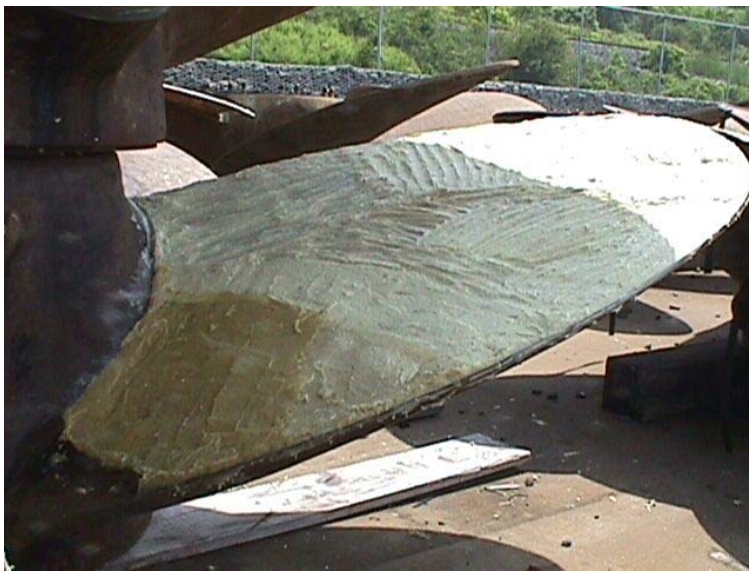
Figure 2.2: Mould on Propeller Blade

The technique of taking moulds is one that BMT FTL has used extensively in damage analysis of pipelines, notably for dents. A compound is applied to the surface and cures to provide a rigid mould that can be ‘peeled’ away from the metal surface and brought to a laboratory for accurate definition of shape. Figure 2.2 shows the mould on the face (aft, or high pressure side) of one propeller blade.

The moulds created for the propellers were much larger than typical pipeline moulds, and some problems with curing were experienced due to the high temperatures and humidity on site. This also meant that more compound had to be used to provide a rigid mould than had been expected when the materials were ordered. Therefore, from eight potential blades only five useable moulds were produced, one of which was for the blade that had fractured. This still provided a substantial amount of potential information.

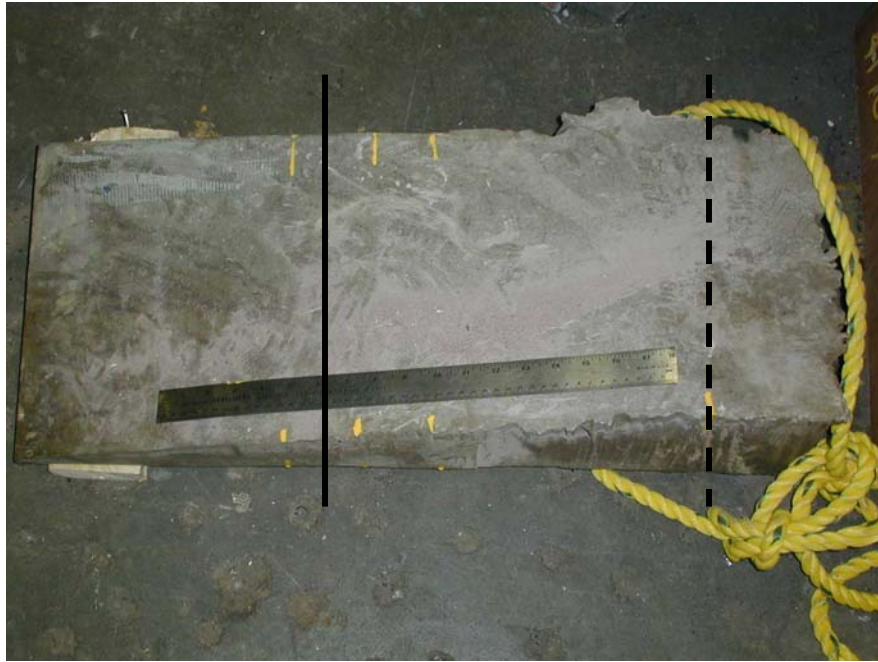
Figure 3.10: Specimen Extraction from Root Region of the Blade

The blade sample taken nearest the root, where the material is assumed to have remained elastic, was chosen for extensive testing and material identification. Within the cut out in Figure 3.10, the two regions selected for the extraction of test specimens are marked. The tensile test specimens were extracted with their loading axis parallel to the marked lines. Comparison is made below with test results from the tensile properties at the fracture initiation region. An objective is to assess the degree of plastic deformation that occurred before fracture.

Samples for chemical analysis were taken from material extracted from two locations for the root region of the blade. One specimen from the sub-surface location (marked by the solid line) and the other from the mid-thickness of the location (marked by the broken line) identified in Figure 3.10 were analyzed at Bodycote Materials Testing Canada Inc., Burlington, Ontario. The method employed used inductive couple (argon) plasma (IPC) instrumentation. The results are presented in Table 3.1.

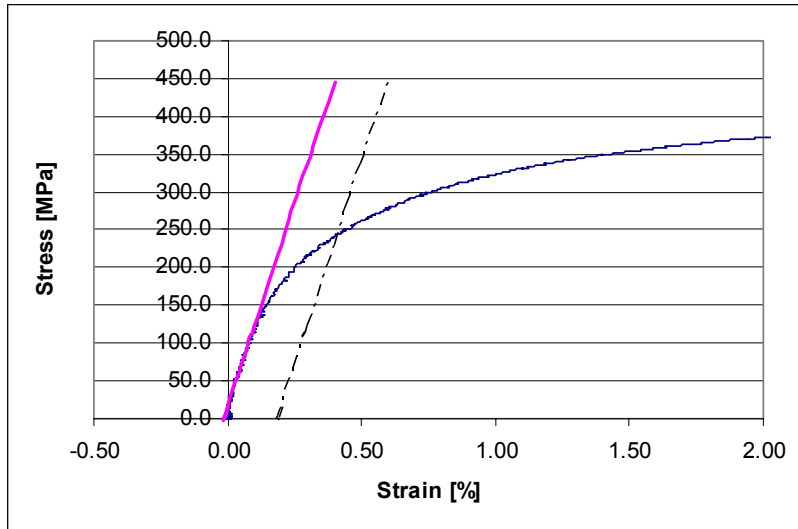
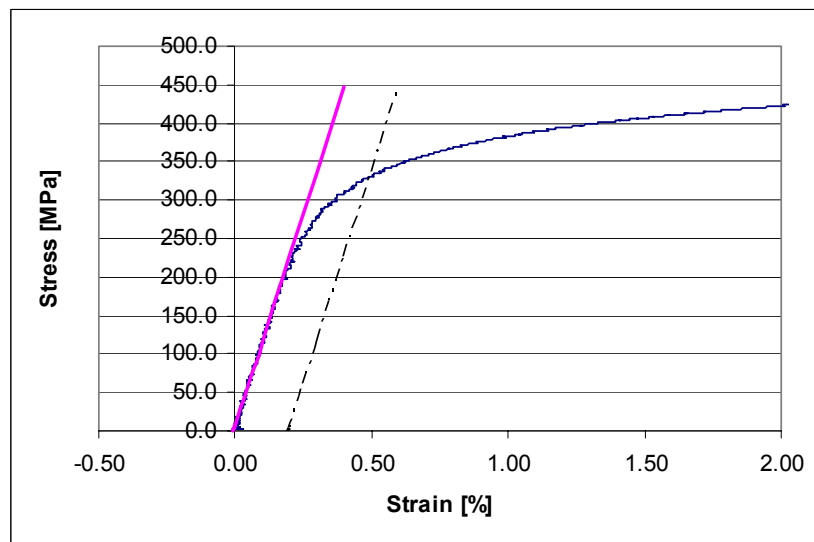
Figure 3.11: Initial Portion of the Stress-Strain Curves of the Root Region Tests (a) Adjacent to Fracture; (b) At Equivalent Blade Thickness and Location

None of the tensile test results from the blade meet the minimum strength requirements for separately cast bars. This is primarily a result of the higher cooling rate of separately cast bars. The duplicate specimens from the fracture region display a higher strength compared to the results from specimens extracted from the root region of the blade. Here, the best comparison would be with subsurface specimens from the root region, where the damage from loading is expected to be minimal. If the yield strengths are compared, the average increase in strength is about 35%. Figure 3.11 shows the initial part of the engineering stress-strain curves for two of the specimens – one specimen extracted nearest the root and one from the fracture region. The elevated flow curve for the specimen from the fracture region is possibly a result of work hardening.

The accuracy of the stress-strain curve used in the model is more questionable. As noted in Section 3, a straightforward comparison of the root and tip (fracture surface) curves indicated that the latter might have seen a 3% strain (Figure 3.12). The FE models, however, show residual strains considerably less than this for even the most deformed blade. This discrepancy suggests that the blade yield strength did vary significantly along the length of the blade, and that the estimates of loads may therefore be non-conservative. A single “worst case” comparison for Blade 1, using the stress-strain curve of Figure 3.11(b) gives a total load of approximately 4.6 MN, or 125% of the lower bound estimate. Peak stresses generated by this load are also roughly 125% of those presented in Section 5. However, these are not realistic comparisons, as the stress-strain curve at the hub is known to be closer to that of Figure 3.11(a), and there is undoubtedly some degree of strain hardening built into Figure 3.11(b) due to the failure mechanism.

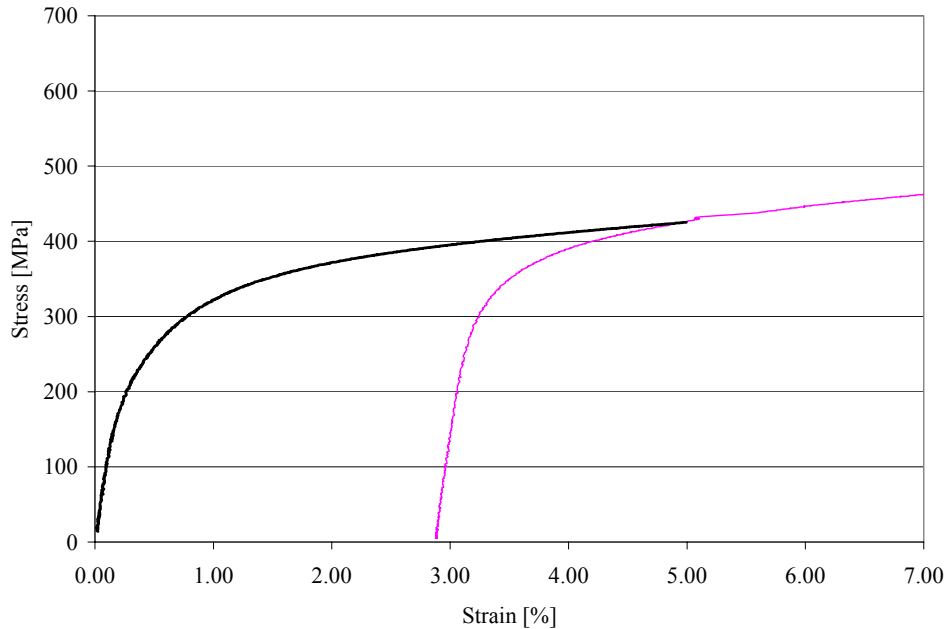
Figure 3.12: Superposition of the Stress-Strain Curves

To assess the amount of work hardening, the curves from these regions were superimposed (see Figure 3.12) and from this method, the estimated plastic strain is about 3%. However, it is also possible that the differences between the curves relate in part to strain hardening and in part to cooling rate and other casting effects – the differing shapes of the post-yield curves and the differing ultimate strengths shown in Table 3.2 provide some evidence for this. This is discussed further in Section 6.

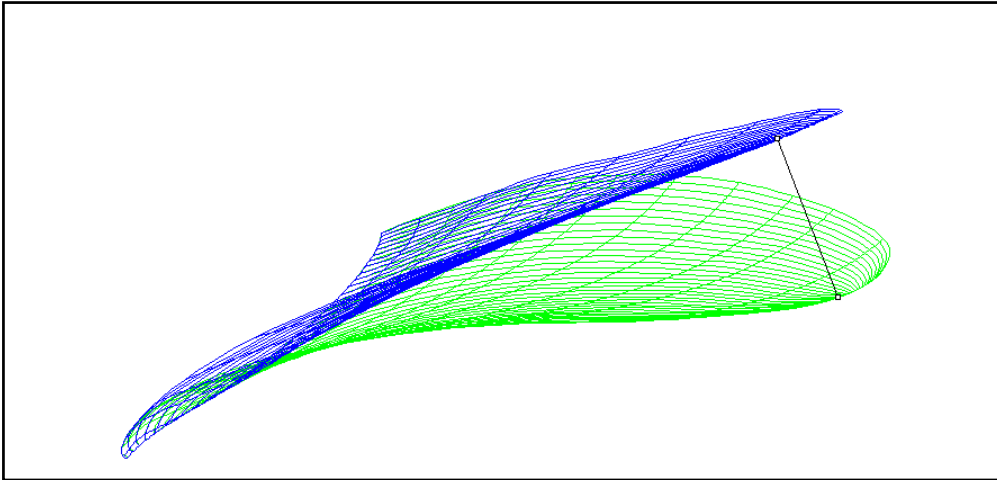
**Figure 5.4: Example of Tip Deflection Measurement
Undeflected Blade (Upper Blue); Deflected Blade 1 (Green)**

Table 5.1 summarizes the extent of the blade deformations derived from the moulds. In all cases this was a combination of bending and twisting. The bending essentially defines the progressive and maximum deflection along the axis of maximum thickness, and the twisting the rotation around this axis, though the shapes are somewhat more complex than this. When deriving the loads that caused the deformations, the bending is principally related to magnitude and lengthwise distribution, and the twisting to the chordwise distribution. Figures 5.4 and 5.5 illustrate how the two measurements were derived.

Blade	Actual from Castings	
	Tip deflection (mm)	Twist at 400 mm from tip (°)
Starboard 1	302.20	5.27
2	198.14	1.68
3	193.76	-0.88
Port 4	59.49	-0.92
5	Broken	Broken

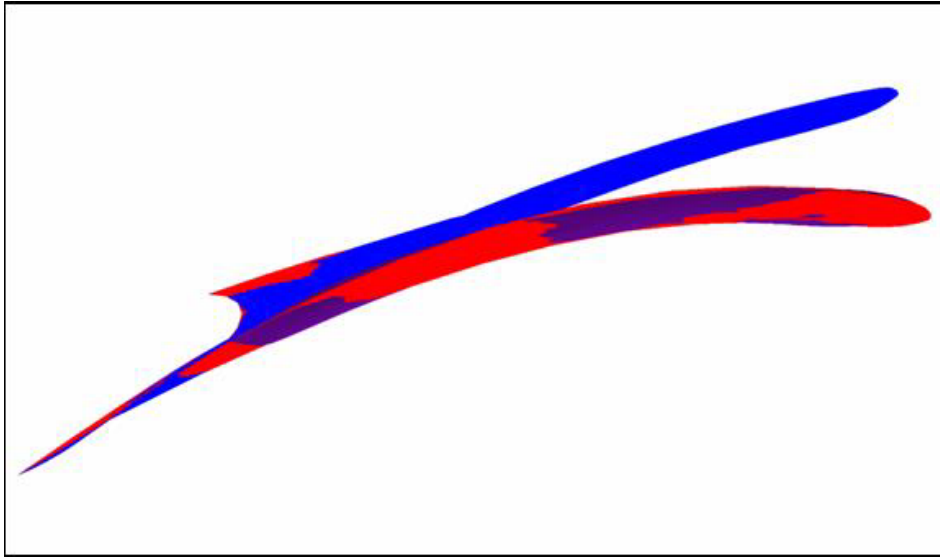
Figure 5.6: Original Starboard Blade + Blade 1 Casting + FEA Rebounded Model

Initially, the load was modelled as a constant pressure over the entire loaded area. Once a reasonable match was found, this was modified to include pressure gradients at each edge of the patch, to provide a slightly better representation of ice-crushing physics. The location and size of the region of the peak pressure were selected using several iterations. After each model was solved, the predicted rebounded blade deformation was compared to the mould measurements. Depending on how well the two data sets compared, modifications were made to the loading until an acceptable match was achieved. Figure 5.6 shows the match achieved for Blade 1.

For all of the blades, the best match of analytical results to the moulded shapes was found with pressure patches over part of the chord from the trailing edge to the centre of the propeller and extended from 0.75 R out towards the tip. The peak pressure in all cases was selected as 13 MPa, over areas that varied between 0.295 m and 0.46 m. The total applied force thus varied from 2.23 MN to 3.69 MN as shown in Table 5.2.

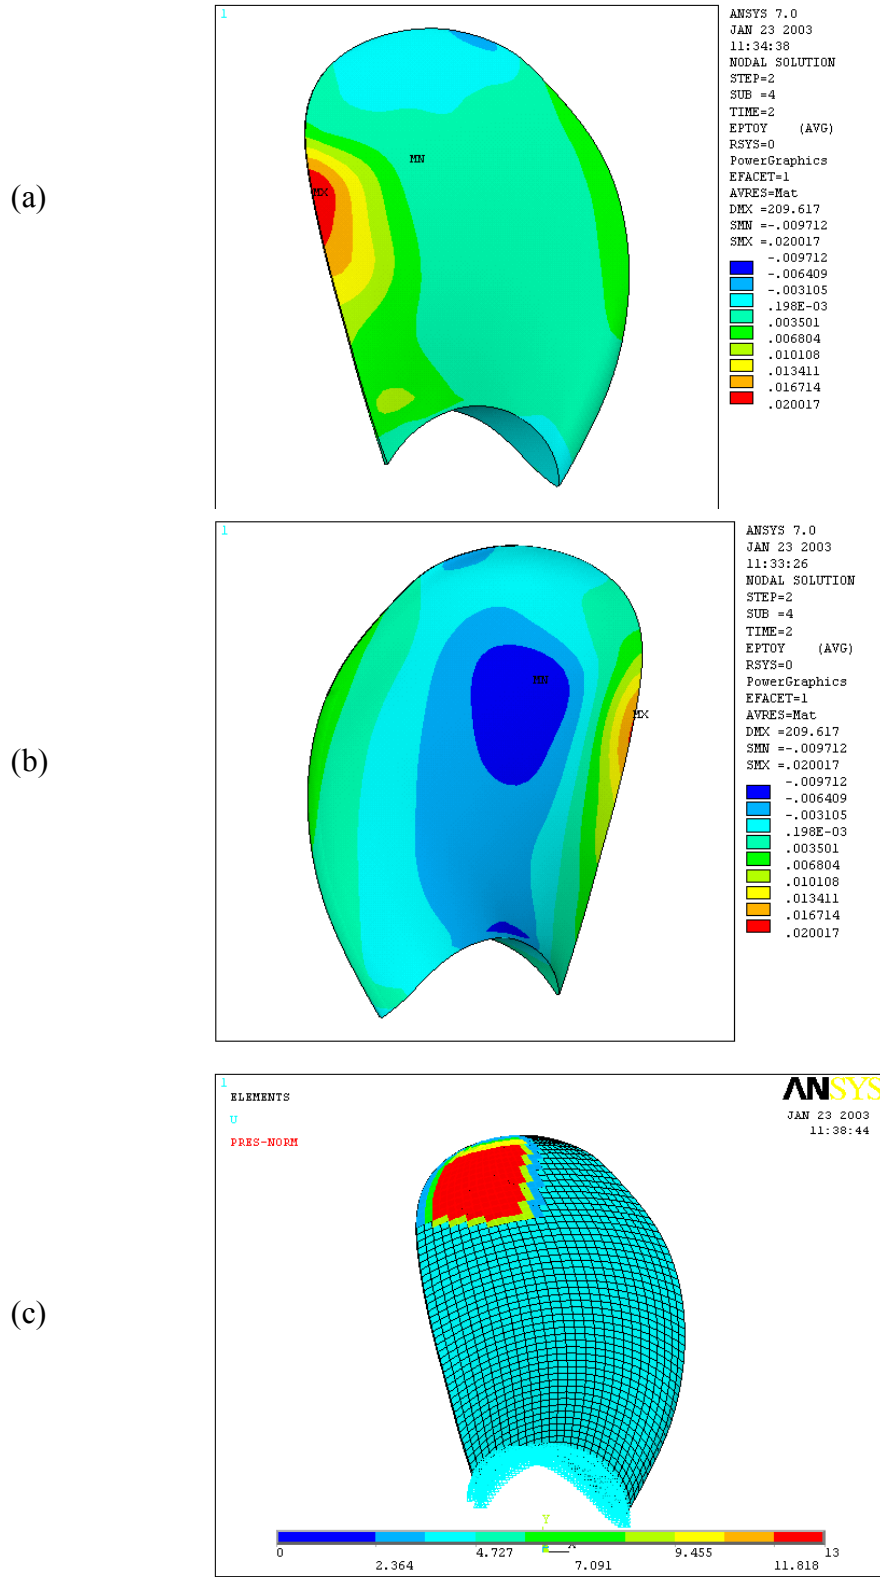
Figure 5.8: (a) and (b) Residual Strains Resulting from (c) Applied Pressure Loading (MPa) for Starboard Blade 2

FE model solutions were generated for three deformed starboard blades (Starboard Blades 1, 2 and 3) and one port blade (Port Blade 1). The pressure loading and residual strains are given for each blade in Figures 5.7 to 5.10. The strain component presented is the Y-direction strain (radially outward) along the blade, or in essence the bending strain component. This component of strain identifies regions of tensile and compressive plastic deformation.

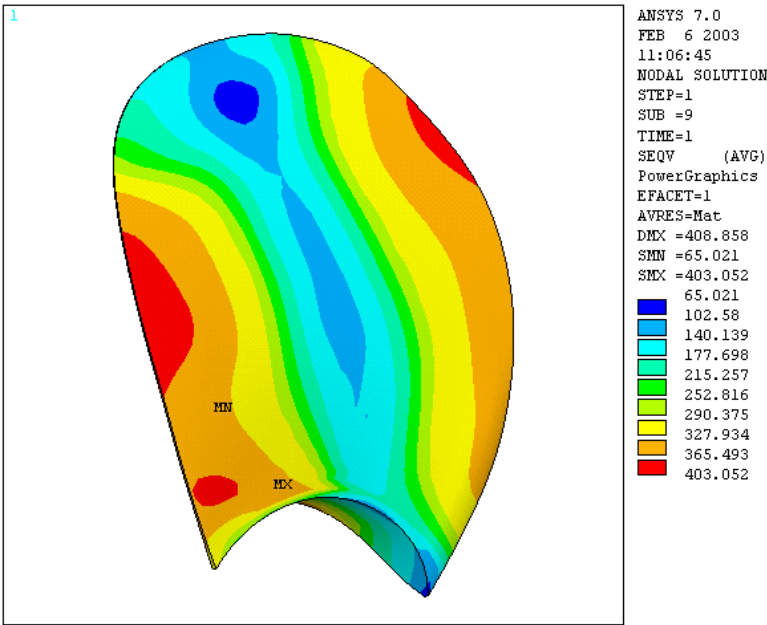
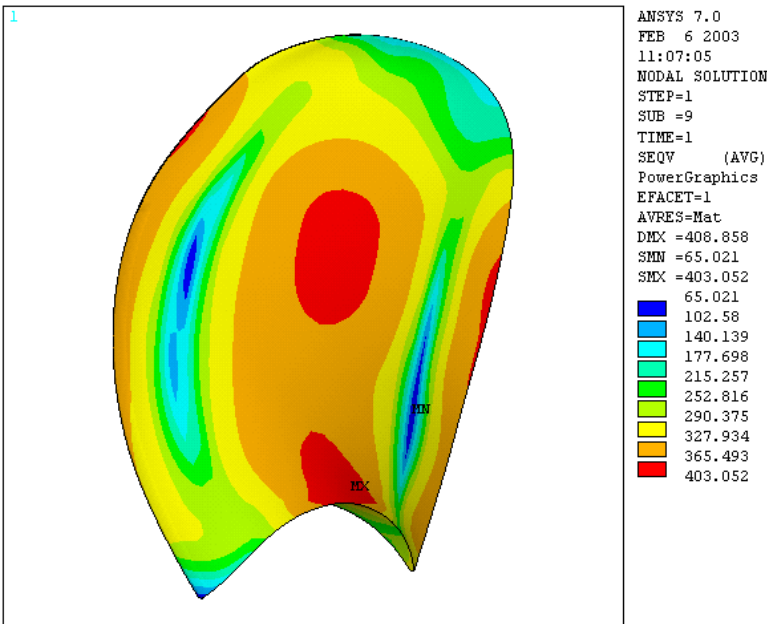
Figure 5.11: Blade 1 Stress Contours

Residual strain is important to the continued serviceability of the propellers, but the stresses of most importance to failing the blades are those at the time of application of the load. Two sets of stress distributions for Starboard 1 and 3 are shown in Figures 5.11 and 5.12. The blades are essentially cantilevers, and therefore the face is put into tension and the back into compression by the load patterns deduced from the models. Table 5.3 shows the peak tensile and compressive stresses (von Mises stresses) for each blade.

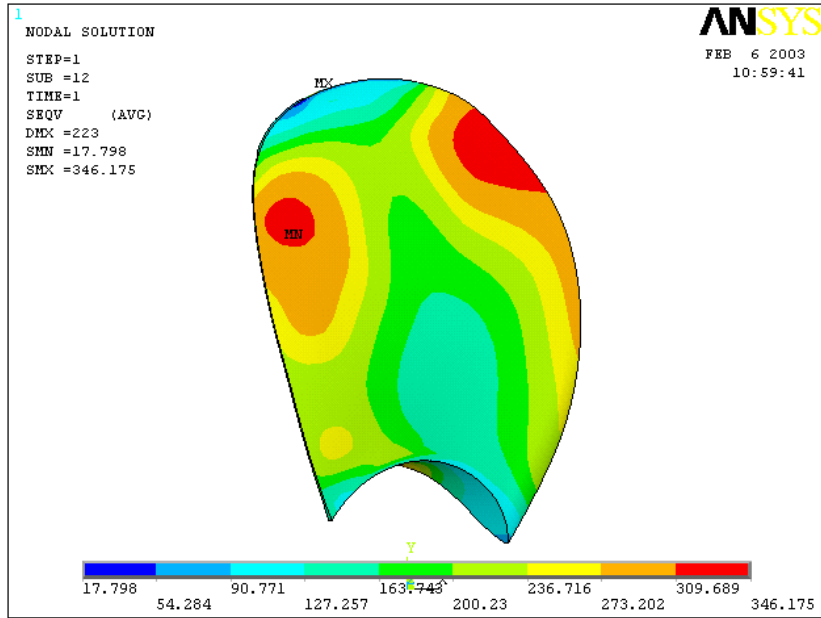
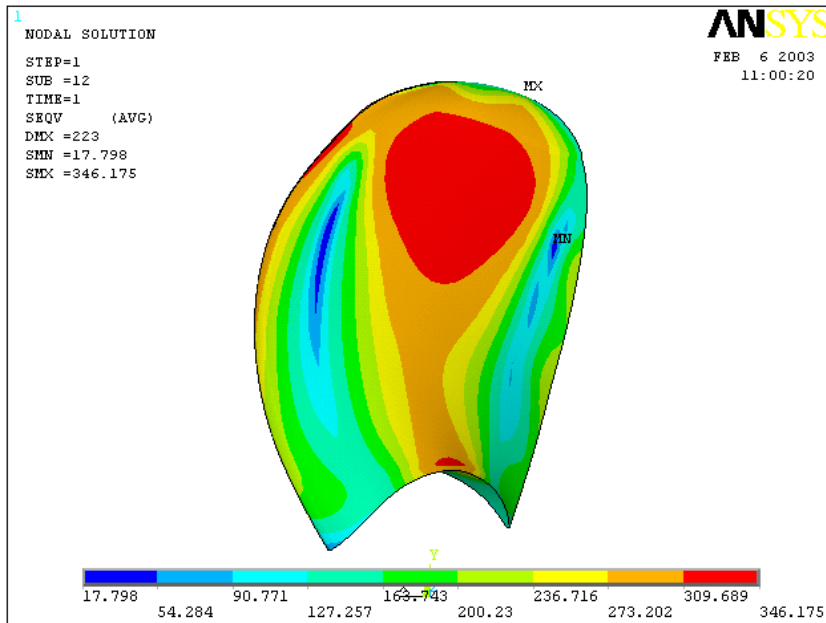
Figure 6.3: UR Load Applied to Tip of Suction Side

Figures 6.3 to 6.5 show the von Mises stress contours resulting from the three load cases. There are some difficulties in applying the UR load model due to the step changes from 0 to maximum pressure, and these result in some local stress concentrations, particularly for the leading edge applications. When these are discounted, the most severe loading case is found to be the tip load (Figure 6.3(b)), with peak stresses of approximately 345 MPa. This value lies between the nominal and actual design values derived above, indicating that the propeller design would have been evaluated as marginally adequate for a PC 3 ship, if the nominal material properties were assumed, and quite inadequate if actual properties were used.

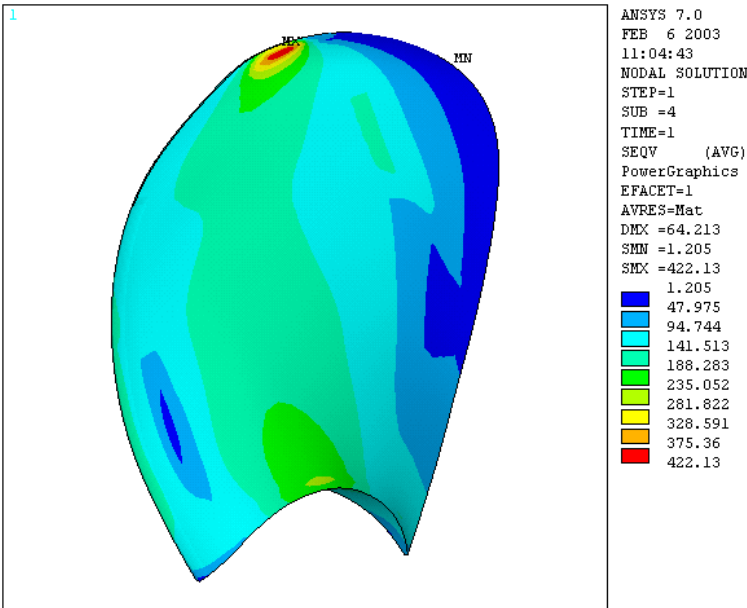
Figure 6.5: UR Load Applied to Leading Edge of Pressure Side

Comparing these load models with the damage loads derived in Section 5, it can be seen that the *Louis* propellers were damaged by a wholly different mechanism. In all cases, the load is applied towards the trailing edge of the blades rather than at the leading edge, and is more distributed than the IACS load model. Load is very definitely applied to the face (pressure side) rather than to the back (suction side) of the propeller.

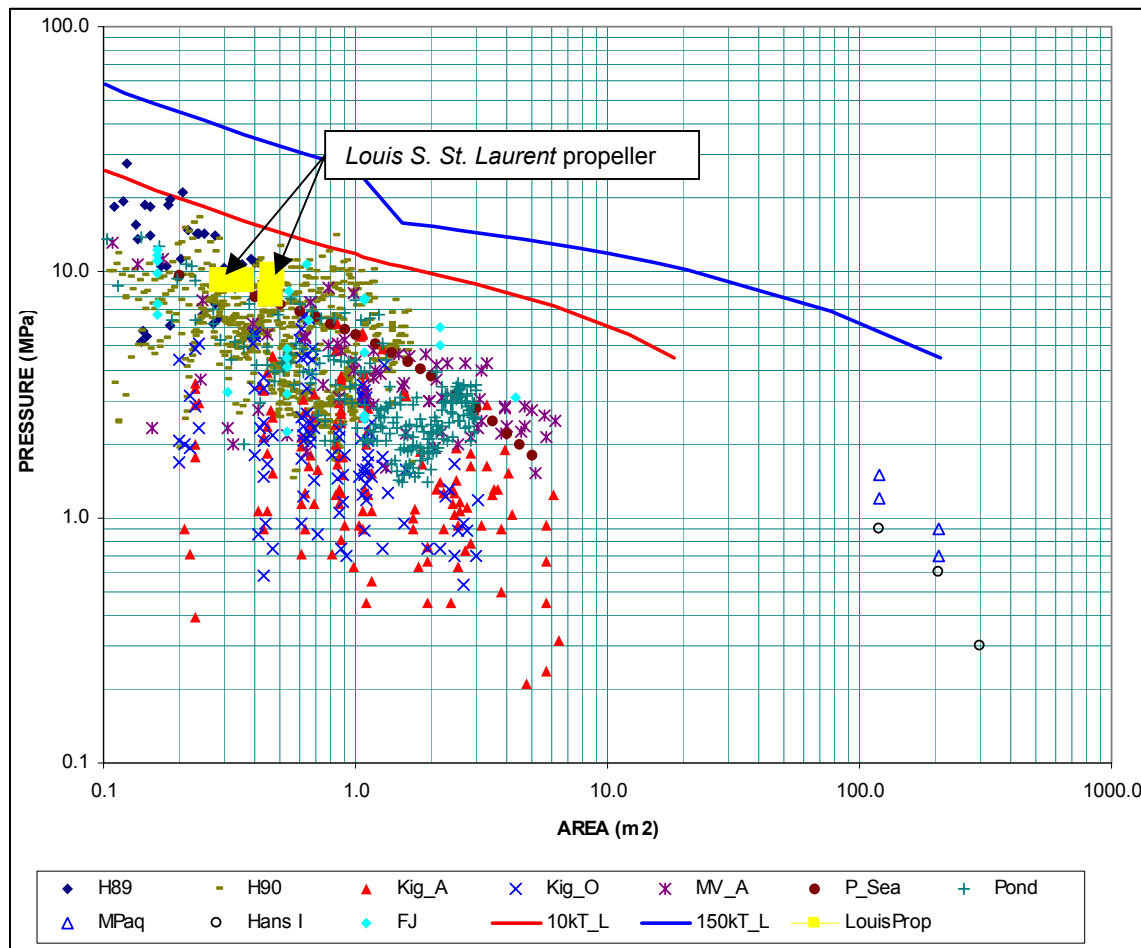
Figure 6.6: Comparison of *Louis S. St. Laurent* and Other Load Data

The loaded areas and peak pressures derived from the FE models (Table 5.2) are of scientific interest, as few (if any) comparable measurements have ever been obtained. Figure 6.6 presents a compendium of ice loading data for ships and offshore platforms, presented in the form of pressure versus area plots. The *Louis* data has been added to the plot and it can be seen that the data falls in what might be considered to be an “expected” range of values for impact loads with strong, thick ice. This is an interesting result with implications for both propeller design and appendage design.
